# BROOKMAN BUILDING

**Conservation works to Brookman building were undertaken to maintain the heritage values of this significant Adelaide building.**

ADELAIDE, SA  
KAURNA COUNTRY  
COMPLETED: 2007

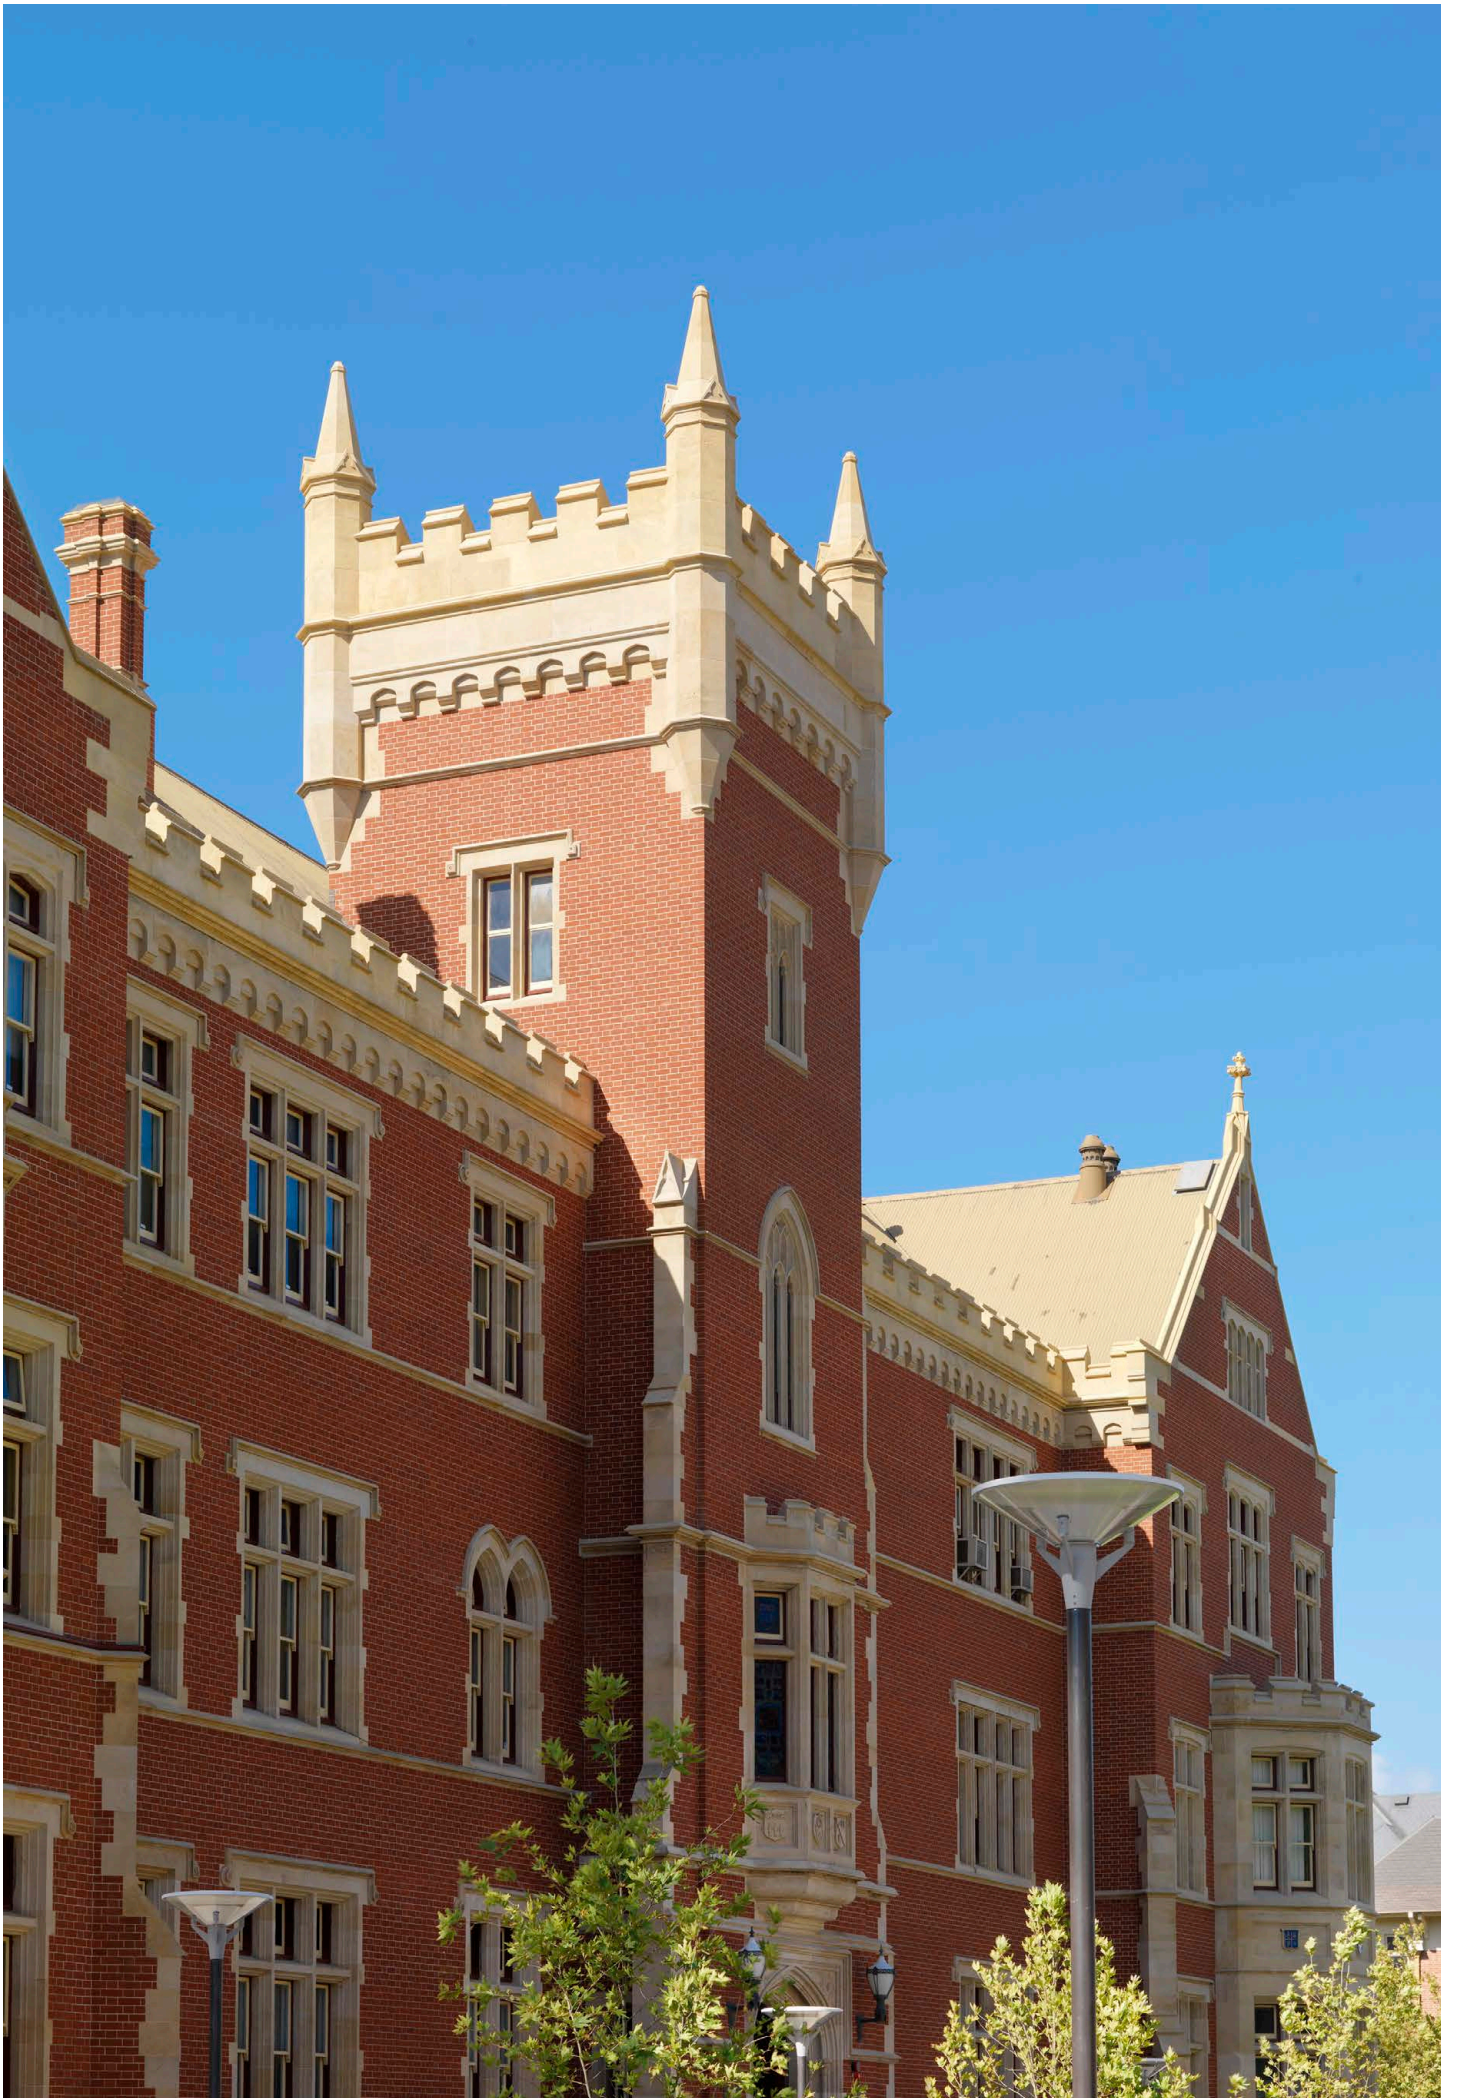
The castellated limestone parapets topping the 1903 building were extensively decayed from corrosion of the embedded steelwork. Reconstruction required sequential dismantling, re-pinning and re-bedding of the parapet stones to prevent collapse under future seismic action.

In addition to the parapet works, the original damp proof course was renewed requiring excavation works around the basement of the building to a depth of three metres and the building facades were cleaned.
